# Manhole Inspection Summary

Manhole # S39I\_\_035MH

Insp Date: **8/20/08 9:20 AM**

**Location** Address: **side 750 e pratt st**

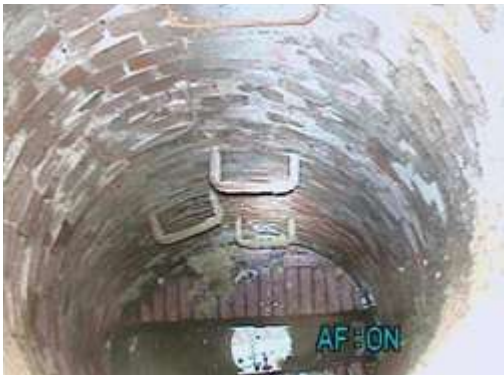
Defect 1

Infiltration: ☐ None ☐ Joint ☐ Cracks ☐ Mortar ☐ Roots ☒ **Wall**

**Steps** Count: **6** Missing: **0** ☒ **Corroded**

infiltration of barrel wall, corroded steps

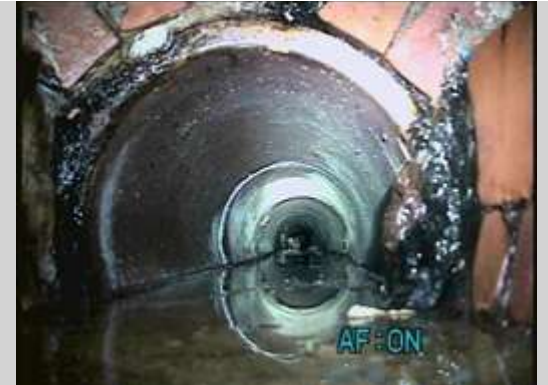
12 O'Clock Outflow

Invert Depth: **10.90** (ft.) Flow Characteristics: **Slow**

Infiltration: **None** Pipe Seal Cond: **Unknown**

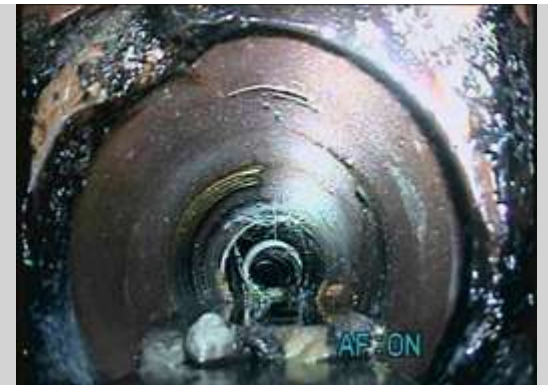
6 O'Clock Outflow

Deposits: ☐ None ☐ Mud ☐ Sludge ☒ **Debris** ☐ Grease

Silt Depth: 2 (in.) Deposits Extent: **Light**
